TOWNSHIP OF LONG HILL SANITARY UTILITY SYSTEM ASSET EVALUATION & CAPITAL IMPROVEMENT PLAN

January 2017

Prepared By:
Remington & Vernick Engineers
232 Kings Highway
Haddonfield, NJ 08033
856-795-9595

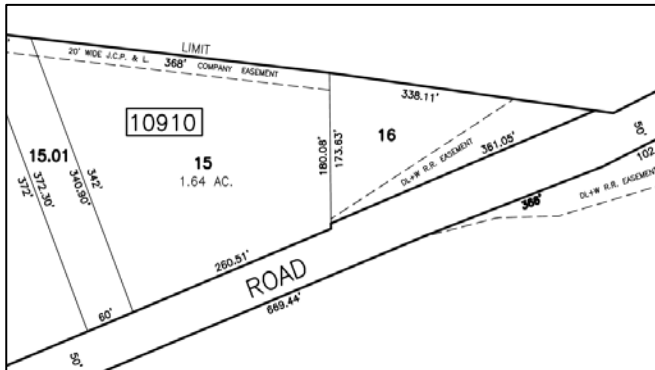
Photo #2 – Tax Map of Site – B 10910 L 15

The station appears to be located on Block 10910 Lot 15 which is a 1.64 acre parcel and is the common lot to the Chimney Rock Inn and office building. Based upon the current tax map shown in Photo #2, there is no easement for the existing station. Accordingly, it is recommended that the Township confirm ownership of the land and obtain an easement, as necessary, for the pump station.

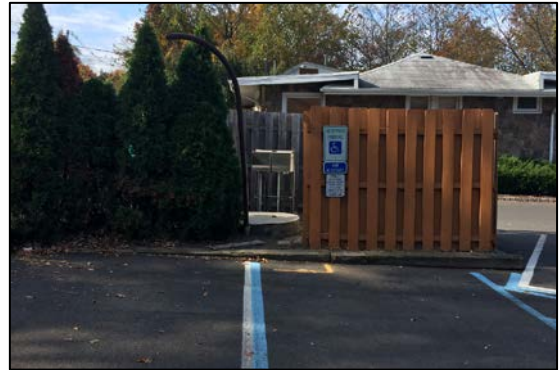
Photo #3 – View from parking lot; no fence

- Review tax map and possible land ownership issues. Obtain easement;
- Security fence around entire pump station;
- Replace two (2) 7.5 HP submersible pumps (twice over the 20 year planning period);
- Replace two (2) check and gate valves in valve vault;
- Replace flow meter (two times over planning period);
- Yard Hydrant Backflow Preventer;
- Possible replacement of generator.

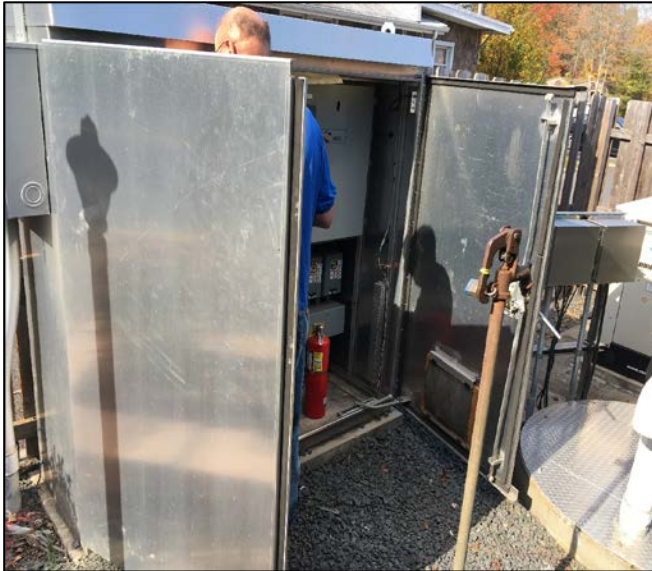
Photo #7 –Electrical panel with yard hydrant in foreground

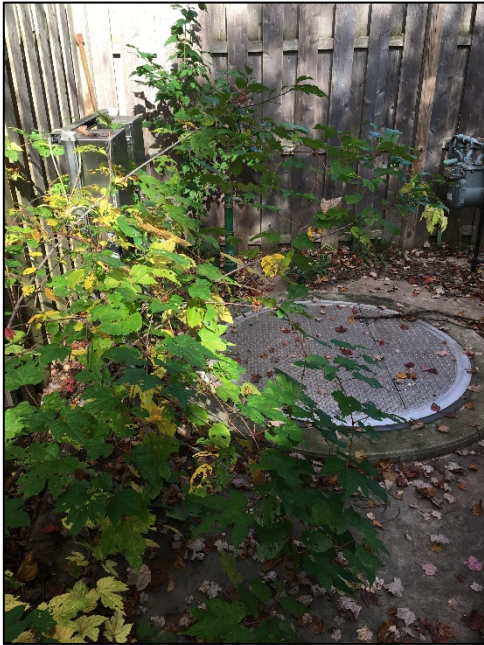
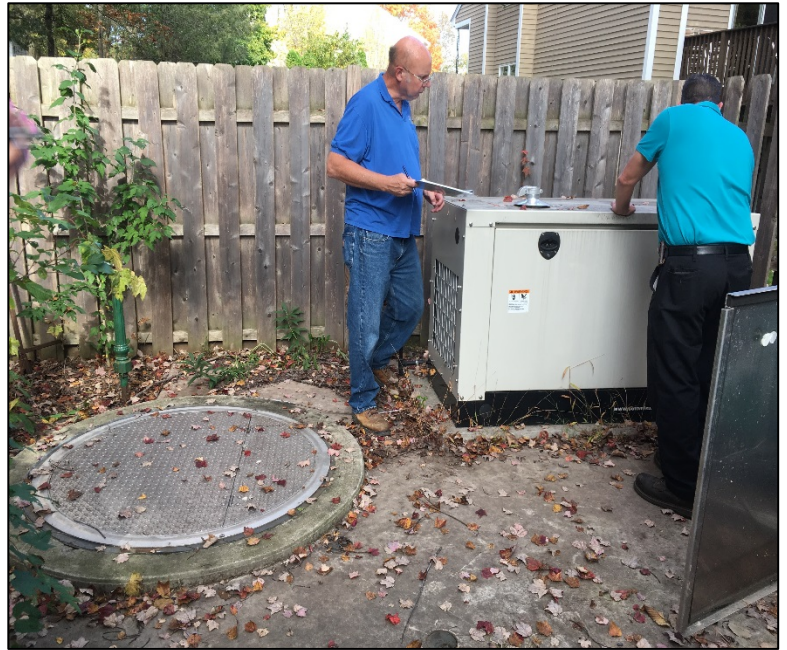
Photo #12 & 13 –Wet Well and Natural Gas Generator

As noted, both pumps are 3 HP Flygt pumps that should be scheduled for replacement. In 2010, a new Cummins 20 KW natural gas generator was also installed.

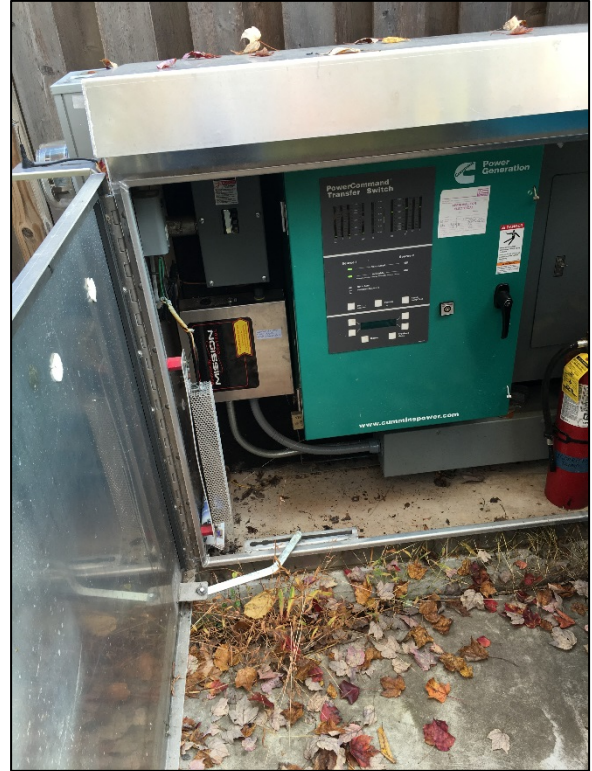
Photo #13 – Service panel sitting on the ground.

Incoming service is 120/240 volt single phase. The meter for the service is located on the electrical service panel. The 100 amp service control panel houses the Cummins Automatic Transfer Switch and Mission Control. The service panel is low to the ground. While this is not a code issue, it creates issues for working in the panel. The Township should consider raising the panel as part of the 20-Year Capital Improvement Plan.

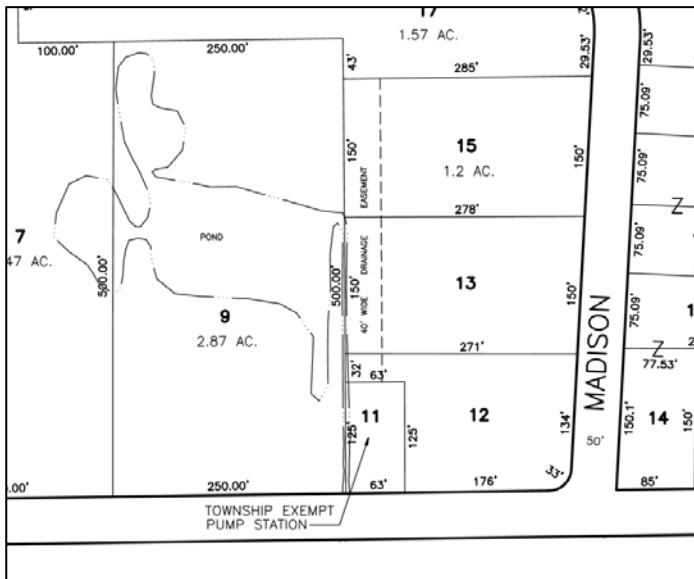
Photo #16 – Station – Block 11203 Lot 11

The site is owned by the Township and is noted to be 63' wide by 125' long. At the rear of the property is a creek / pond and drainage easement. In addition, the area is wooded. Some of the trees surrounding the site are infringing into the fenced area. Some damage from falling limbs is apparent on the building. It is recommended that maintenance / removal of trees surrounding the site be completed to prevent future damage.

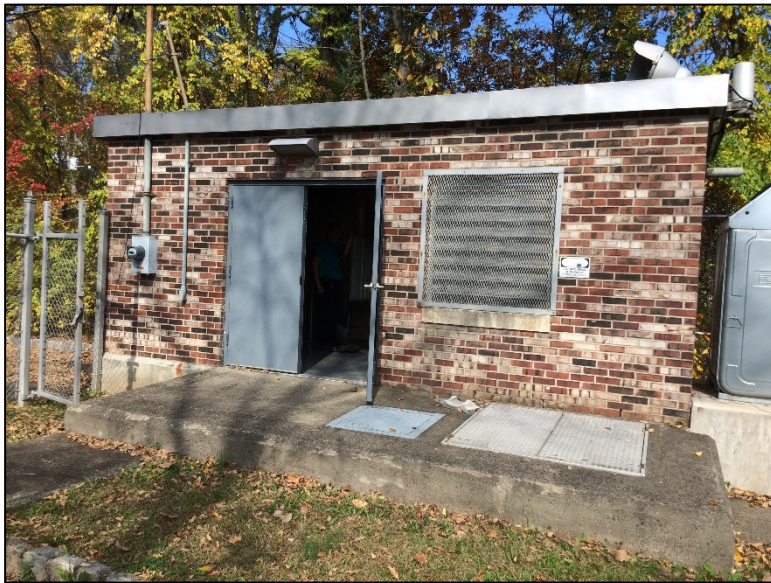
Photo #17 – Front view of pump station; driveway to the left

The steel lintels at wall penetrations are rusted and should be cleaned and

repainted. In addition, metal capping at the north-west corner of the roof is damaged from falling limbs and needs to be replaced. Minor cracking is evident at the foundation corners and should be patched to prevent moisture infiltration and should be monitored for further damage.

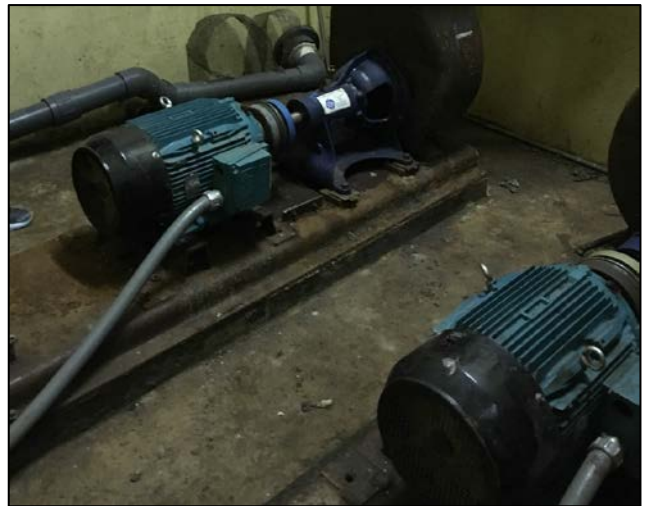
Photo #20 – Gorman Rupp pumps

The pump motors have been replaced within the last 10 years. The pumps motors should be planned for one additional replacement during the 20-Year planning period. Based upon information provided by the utility personnel, the check valves in the station have been replaced in the station within the past 10 years. Planning should incorporate the replacement of the gate valves at the same time as the pump/motor replacements.

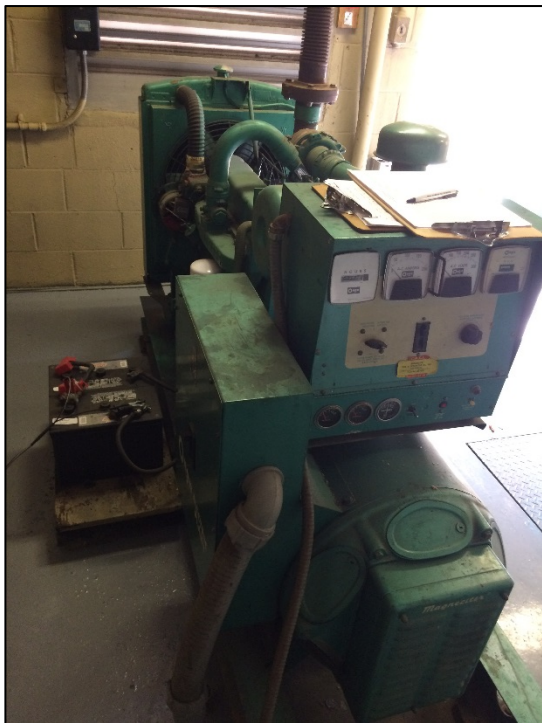
Photo #22 – Diesel emergency generator

gallon above ground double wall tank installed on an elevated pad at the rear of the site. There is a day tank with a supply and return line that provides fuel from the tank to the generator. The Utility personnel believe that the generator is original to the building. Accordingly, for planning purposes, the Township should incorporate a generator replacement for this station during the planning period. At the same time, the generator should be relocated outside.

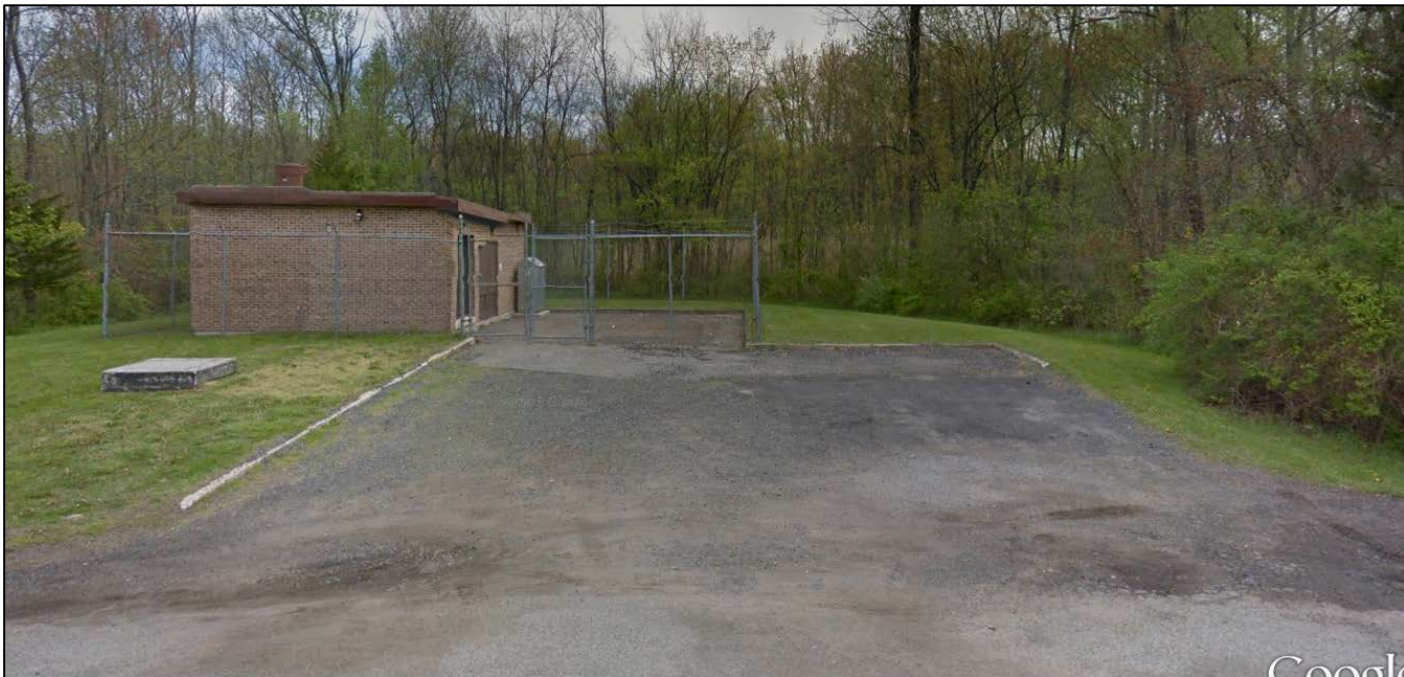
Photo #26 – New Vernon Pump Station – view from New Vernon Road

Access to the station is off of New Vernon Road via an asphalt milling drive way. There appears to be areas of degradation and rutting in the driveway and access shoulder. The driveway will need maintenance and addition of material during the planning period. Accordingly, it is recommended the access driveway and shoulder be paved to reduce further maintenance and repair costs in the future.

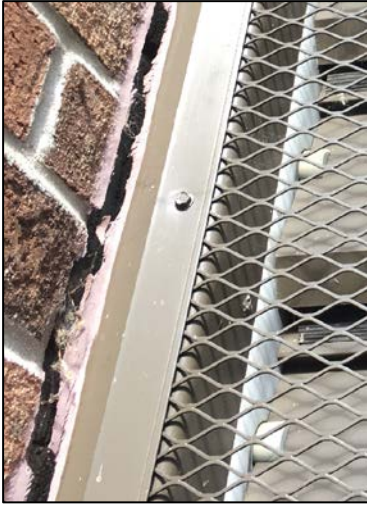
Photo #29 –Separation around louvers

Minor slab cracking is evident around the interior generator pad and should be monitored. There is a hoist beam with a 1 ton hoist within the station that is aligned with the access hatches in the floor. The doors and louvers appear to be original to the building and vertical separation is apparent in the sealant between the frame and wall. This separation should be filled, sealed and monitored to prevent water infiltration behind the exterior and degradation of the brick.

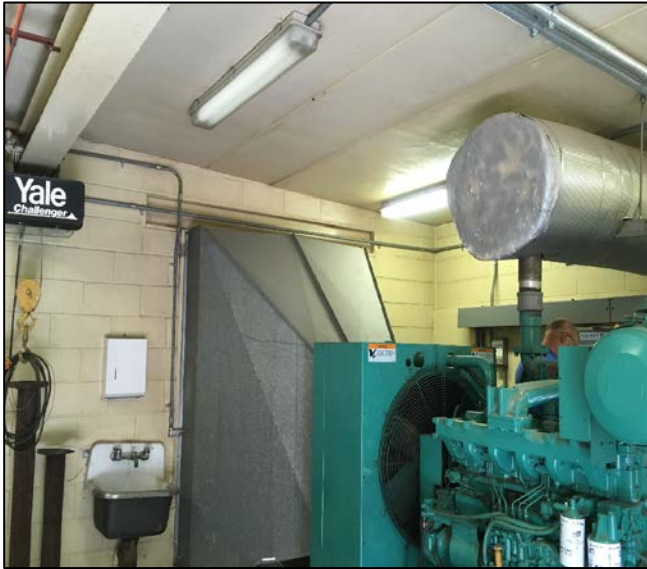
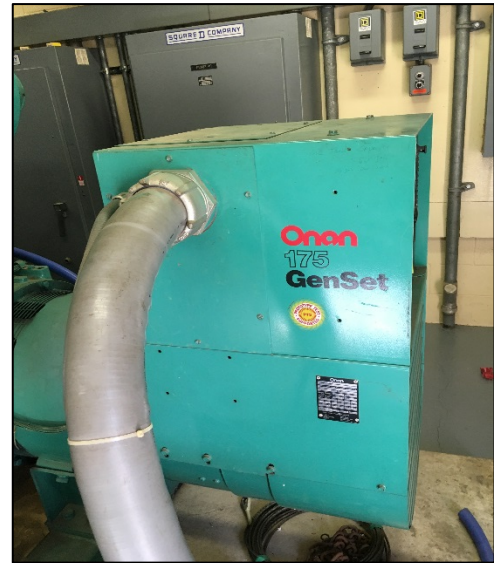
Photo #34 & #35– Diesel emergency generator – inside building with air intake

The generator for the facility is an Onan diesel generator rated at 175 kW. The generator is fed by a 275 gallon above ground storage tank located on the side of the building. Based upon information provided by the utility, recent NJDEP inspections have resulted in the comments that the generator is required to be moved to the exterior of the building. Should these inspection comments hold true, a new diesel generator should be moved to the exterior of the building on a reinforced concrete pad raised above the flood elevation. The supply and return piping should be re-piped and fence modifications/additions to enclose the generator should be completed.

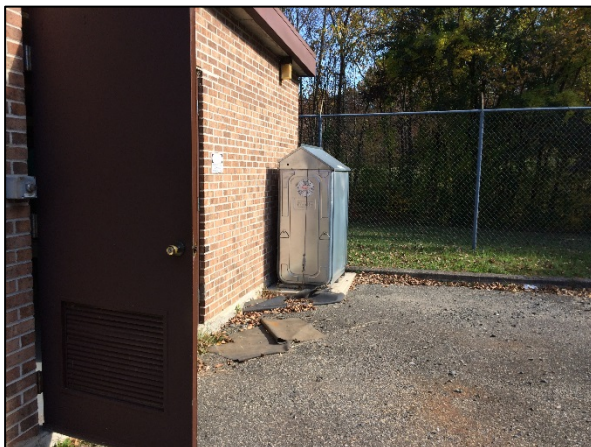
Photo #36 – Diesel Aboveground Storage Tank

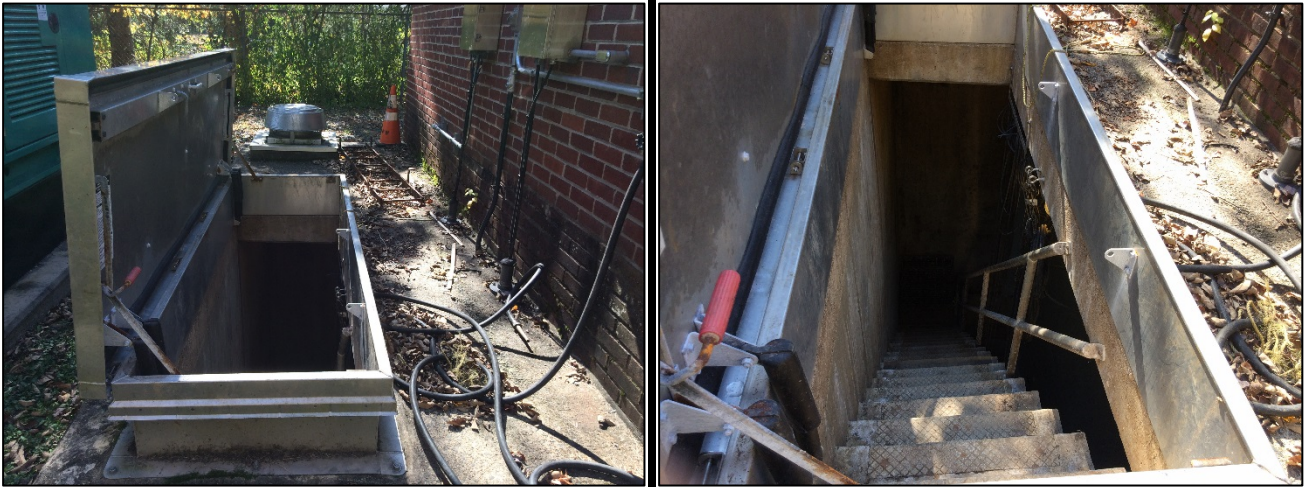
Photo #44 & #45 – Stairs / hatch to grinder

The pump station is a duplex pump station with a building that consists of poured concrete foundations supporting concrete walls with an exterior brick façade. Exterior steel lintels appear rusted and should be cleaned and painted. The below grade poured concrete walls extend to the wet well level. An exterior hatch at the rear of the building provides access to stairs leading to a grinder. At the time of construction, no access was provided to enable utility personnel to remove the grinder for cleaning, repairs or replacement. The wet well / grinder access should be modified to allow proper maintenance of the grinder and continued operation in the future.

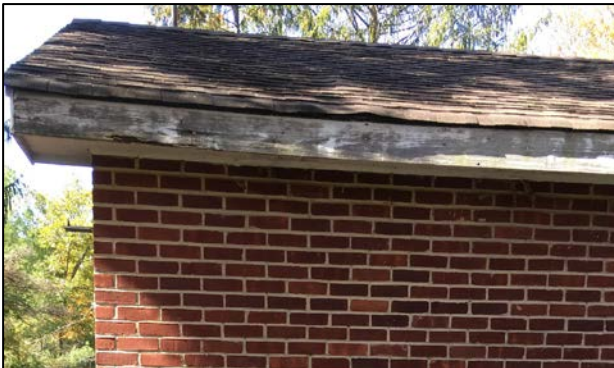
Photo #46 – Soffits, shingles, fascia needing replacement

appear to be in poor condition and should be replaced. Existing gutters are damaged or missing and the entire gutter system should be upgraded to protect the structure from water infiltration. The wood soffits and fascia boards are also in poor condition and should be replaced.

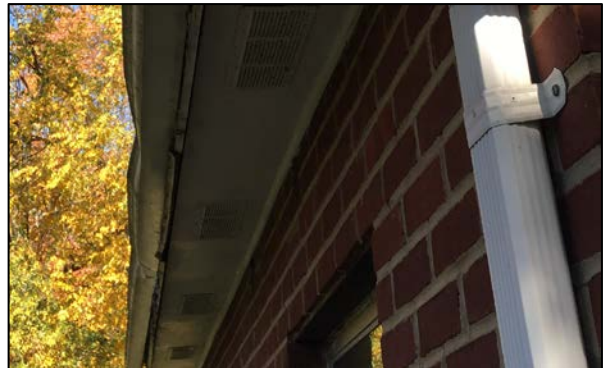
Photo #47 – Missing gutters

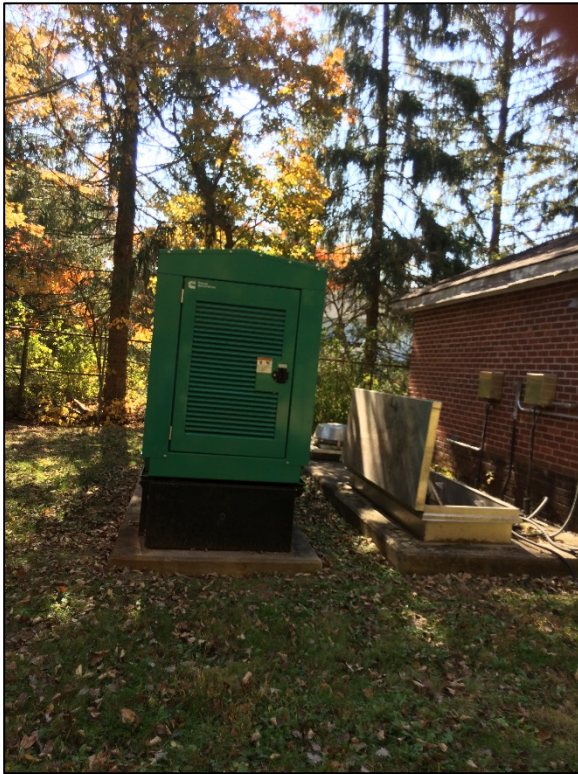
Photo #48 –Diesel Generator at rear of building

The generator for the station was installed in 2011 and is an Onan diesel generator rated at 250 kW. The Township maintains the generators and has an outside contractor inspects the generators once a year. Based upon the age of the generator, replacement *may be* needed during the 20-Year planning period. The Township should be aware that, based upon Federal guidelines, the lifespan for a generator is recommended to be 15-20 years. Due to the cost of generators, municipalities typically will allow a generator to remain in use past this recommended lifespan. While we do not recommend replacement of equipment that is operating to its original design parameters, we do recommend that the Township is aware of typical useful lifespans of equipment and plan accordingly.

In addition, it was noted that the existing generator is not sound attenuated. Due to its location near a residential neighborhood, it is recommended that when the generator is replaced, a sound attenuated generator be specified.

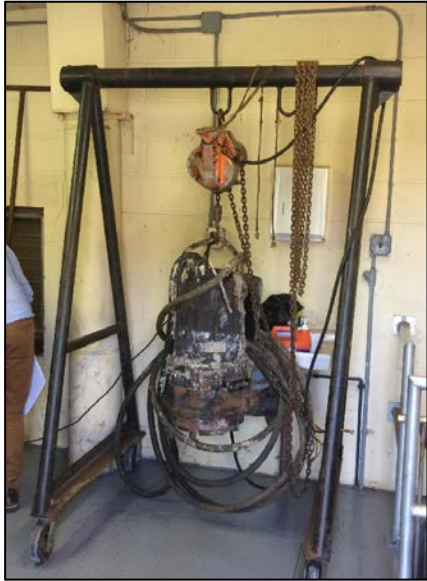
Photo #55 & #56 – Existing hoist – to be replaced

Interior to the building is a ½ ton capacity hoist. The hoist is original to the building and does function as required for the plant and personnel. A new I beam structure and suitable hoist should be incorporated into the capital plan and should incorporate current worker safety requirements.

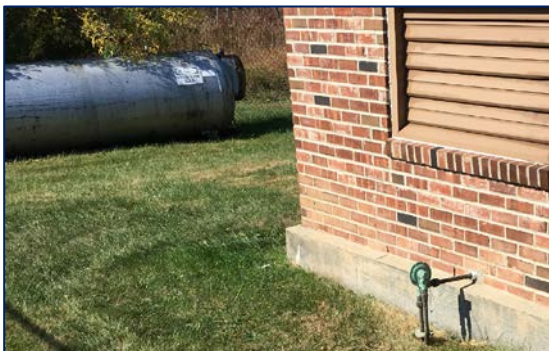
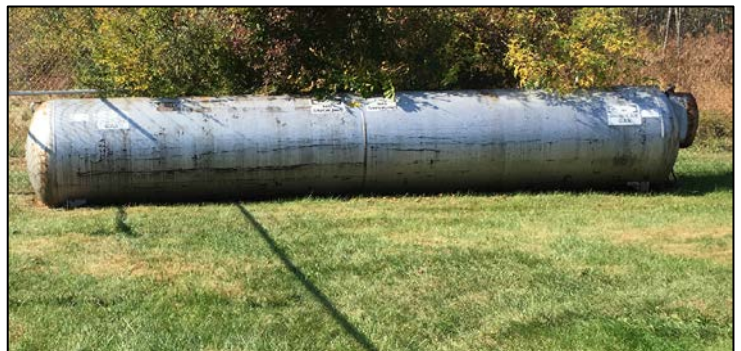
Photo #57 & #58 – Propane Tank at rear of site

At the rear of the site is an 1800 gallon above grade propane tank that was built in 1950. The tank is sitting on bare earth and is sinking at one end. Portions of the tank

are rusted and bare metal is exposed. The tank needs to be replaced. It would be our recommendation to contact the Township's propane supplier and request a new tank. Due to today's installation requirements, the new tank may need to be relocated and/or put on a pad. Typically, the propane suppliers will require all tank pads and piping be in place and approved by the local code official before they will set the tank.

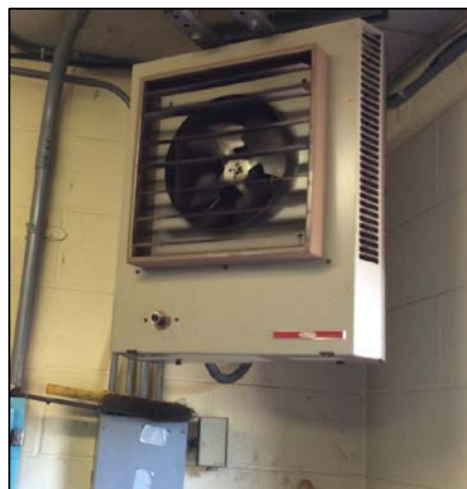
Photo #60 – Electric Heater – to be replaced

The ventilation system of the station also requires upgrades. The ventilation system is a regulatory requirement that not only extends the life of equipment but reduces the buildup of gases and provides worker safety. Other features of the station which require upgrades/replacement are the flow meters and heating system.

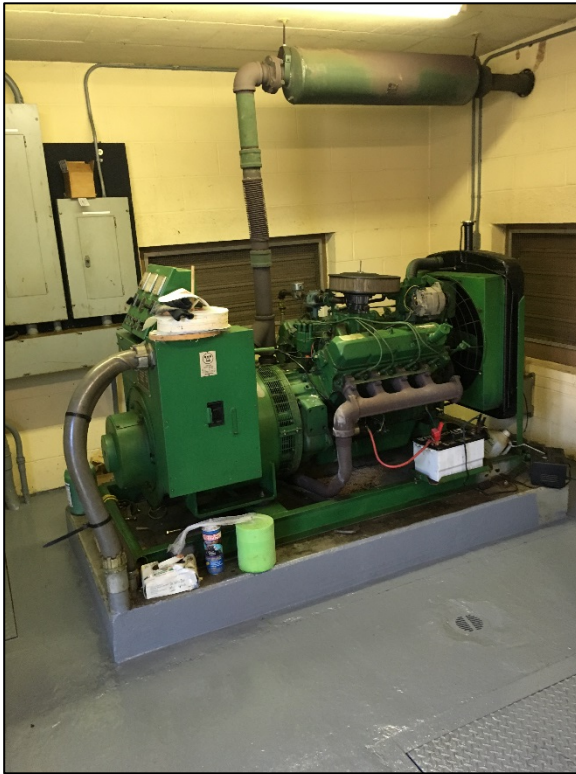
Photo #61 –LP Emergency Generator

The Maxi-Power L.P. generator at the station is 85 Kw and is older in nature. Utility personnel did not recall when it was installed. Maxi-Power generators were first used in late 1970's. Accordingly, it is assumed that the generator is at least 35 years old. Accordingly, it is recommended that the generator be scheduled for replacement as part of the 20-Year Capital Improvement Plan. At the time of replacement, the generator should be installed outside on a reinforced concrete pad.

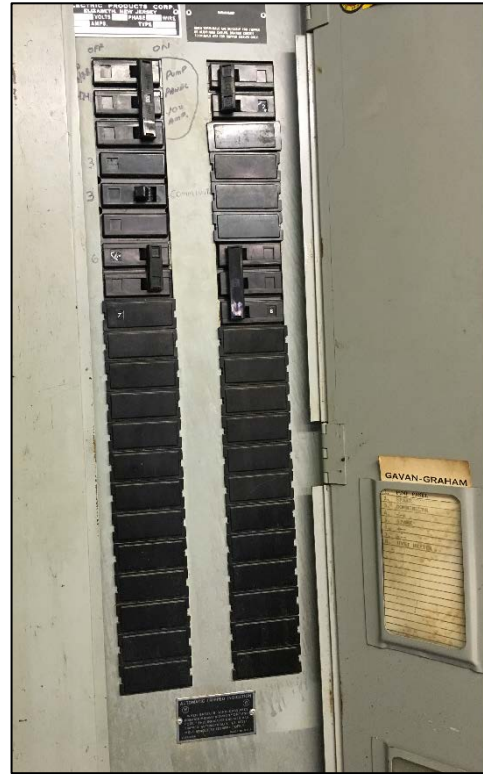
Photo #62 –Electrical Service Panel

The service to the site is run above grade and appears to be running through the utility easement from Rolling Hill Drive. The service is 120/240, 3 phase and has a 200 amp main panel. The electrical system in the station is older and will require upgrading within the next 20 years. At the same time, the control panel should be upgraded.

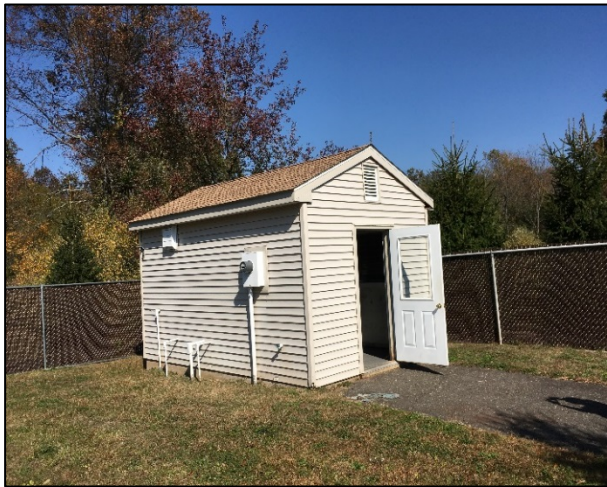
Photo #67 – Emergency Generator / Control Building Photo #68 – Soffit requiring replacement

The building onsite is made of wood framing with a vinyl siding. The roof is pitched with newer dimensional shingles. The structure is in overall good condition with some missing or damaged siding and a soffit that should be replaced.

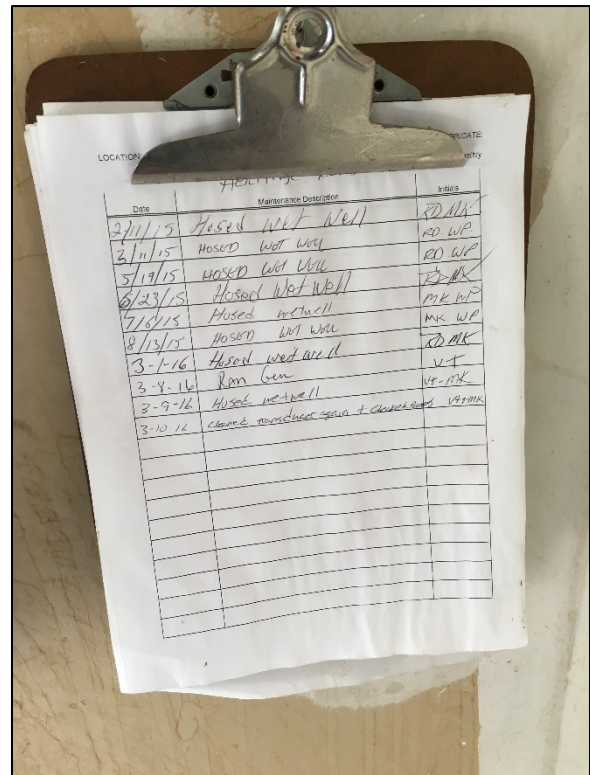
Photo #74 –Maintenance Log

The pumps operate off floats / transducers which are cleaned off by the utility personnel once per month. However, as can be seen from the above logs, the maintenance at the facility has become less frequent. As noted by the utility personnel, the reduction in staffing has impacted their ability to complete routine inspection and maintenance of the system. It was noted that the utility department has been reduced from 6 personnel to 4 personnel. Consideration should be given to the addition of part time or full time staff to assist in the daily operational requirements of the sewer department.

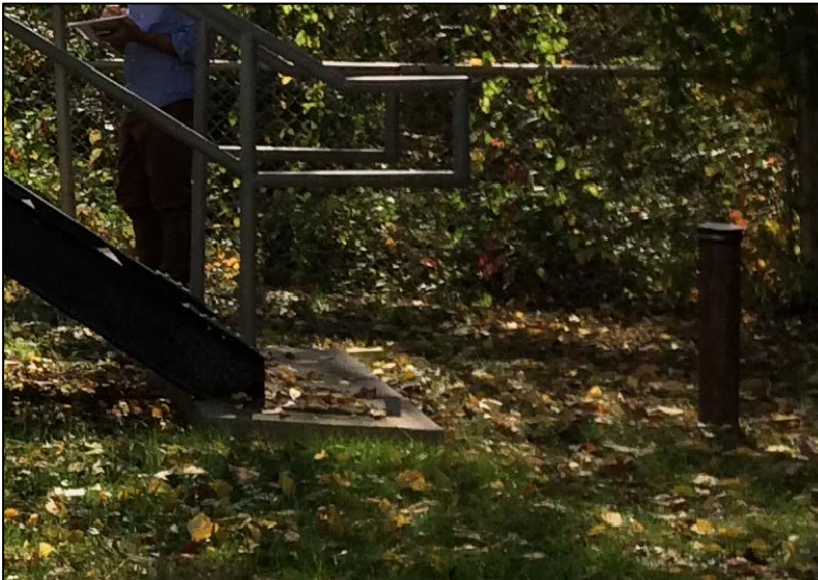
Photo #79 – Possible groundwater monitoring well

At the time of the facility tours, it was noted that there appeared to be a ground water monitoring well located on the site; adjacent to the stairs access the elevated platform. Should the Township choose to sell the utility, clarification on the nature of the assumed monitoring well will need to be provided.

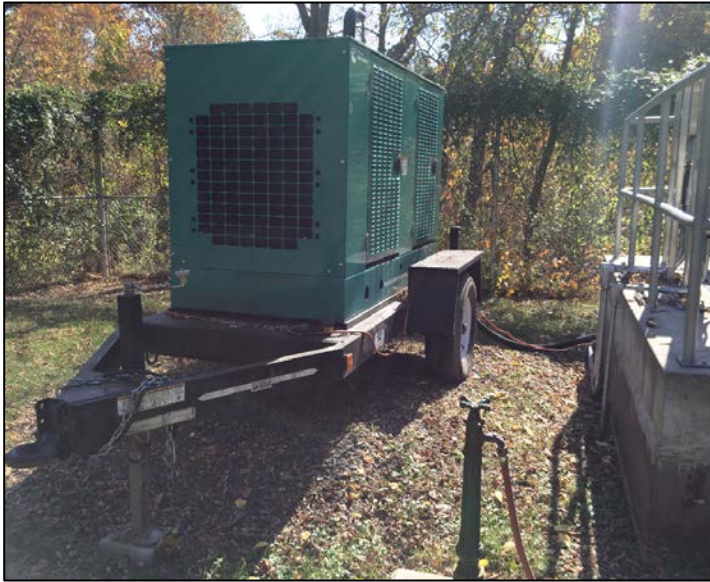
Photo #71 – Diesel emergency generator

The Onan 50 Kw diesel generator for the station is not permanent (on wheels) and is connected to the pump station electrical with a wire and plug. In addition, the generator is not elevated above the presumed flood elevation. In addition, the generator does not have an automatic transfer switch. Accordingly, in the event of an emergency, the generator does not automatically turn on and utility personnel must man the station. The generator should be raised to the same elevation as the control and electrical panel and should be permanently fixed. In addition, an automatic transfer switch should be installed at the same time.

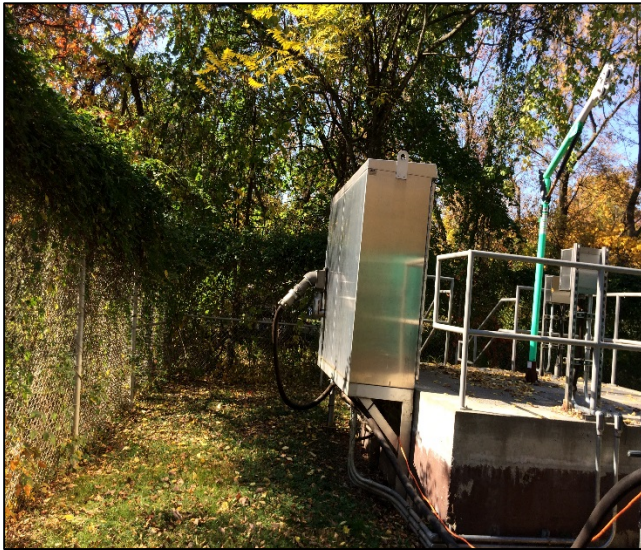
Photo #73 –Electrical service panel

Incoming service is 120/240 volt three phase. The service comes from Union Street by above ground utility poles. The electrical meter is installed on the exterior of the main service panel. The main service panel provides 200 amp which appears sufficient for the station.

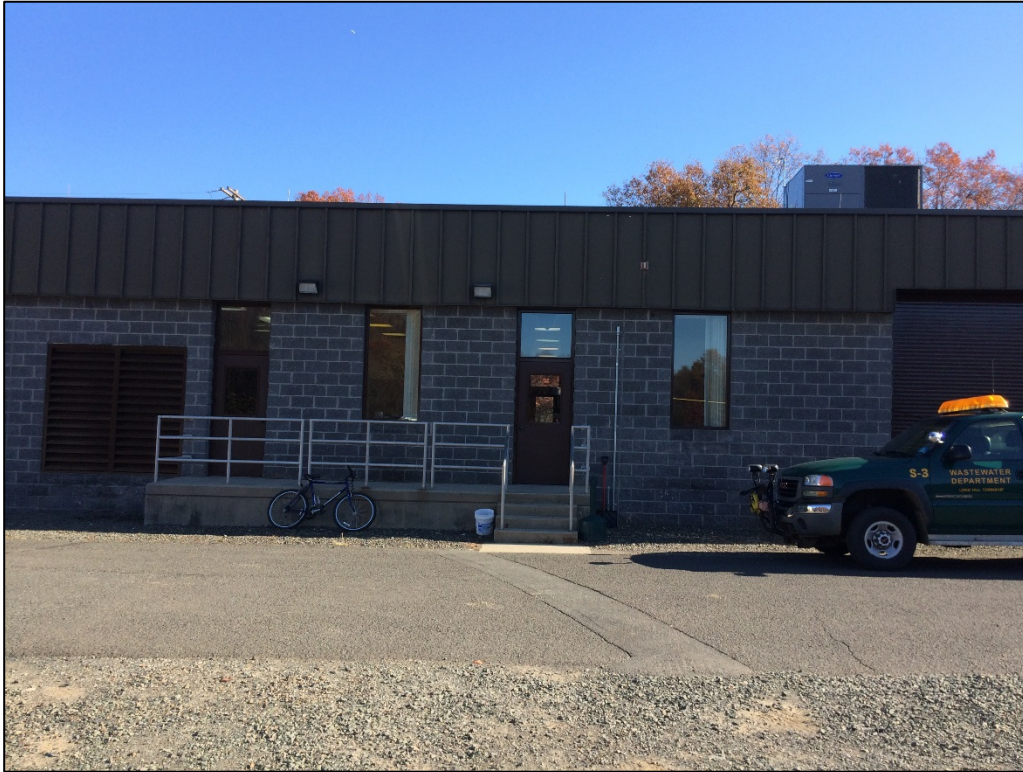
Photo #78 – Main Building

The main building is located at the front/entrance of the site and provides several different functions for the facility. Within the building is the operator office, plant laboratory, lime slurry room, generator room, boiler room, control room and worker break room.

No major structural damage was apparent at the time of inspection. Some stress cracks are evident in the walls around lintels and in the slab around floor drains and raised equipment pads. These should be filled with non-shrink grout and monitored for increasing crack width.

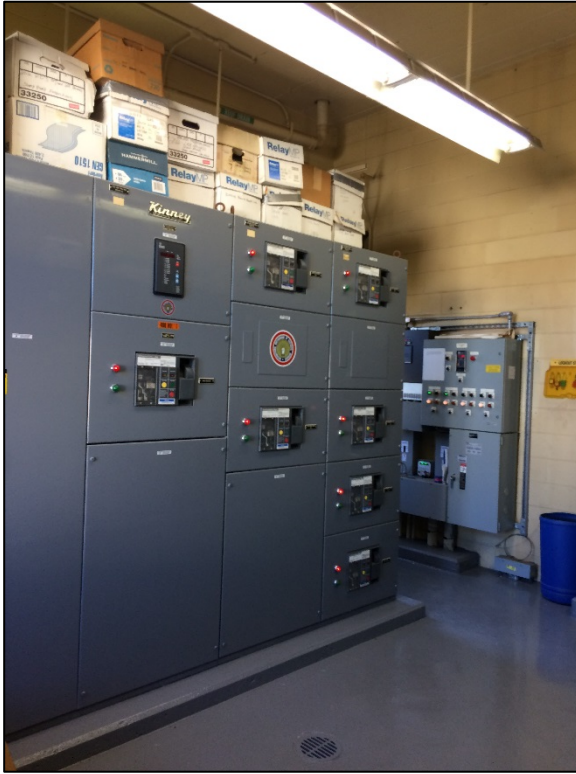
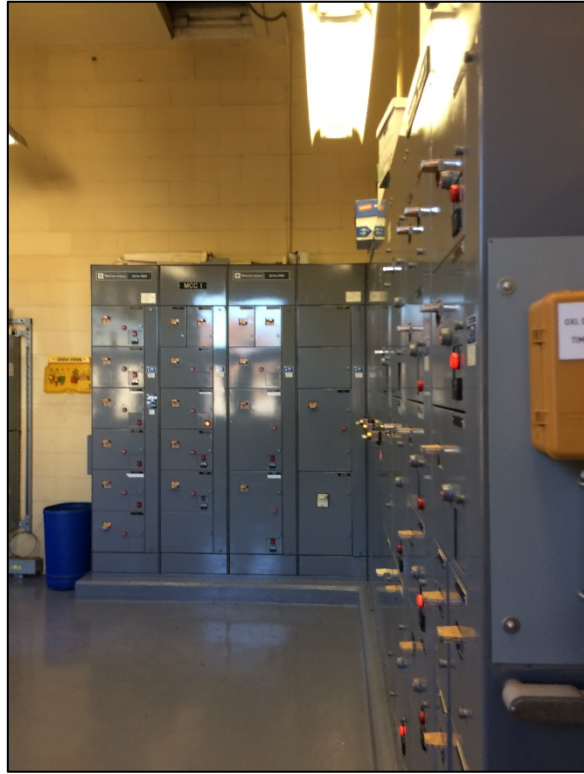
Photo #79 & #80 – Control Room

The control room is new in age and houses the incoming electrical and controls for the main building, both oxidation ditches, four (4) pumps with Mitsubishi F-700 VFDs and aerator controls. The incoming electrical is 480 volt, 3 phase and serves a 1200 amp main panel.

It was noted that the alarm panel is not working. The alarm panel indicates the high level for the digester, high wet well level and generator run alarm. Based upon how the plant is operated, additional alarm additions are warranted as follows:

- Addition of low pressure alarm for sand filters;
- Addition of seal failure alarm for sand filters.

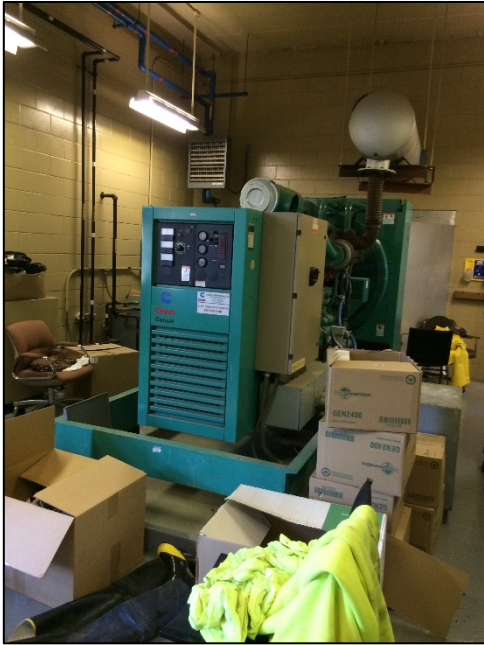
Photo #81 – Generator

The generator is 500 kW and is approximately 26 year old. It is anticipated that the generator will be required to be replaced during the 20 year planning cycle.

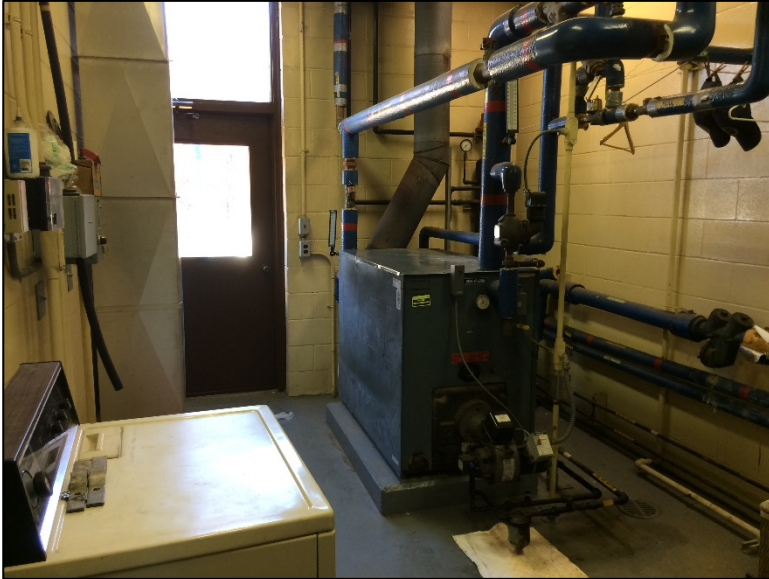
Photo #83 – Boiler room

The boiler room is located adjacent to the generator room. Located within the room is the boiler for the Main Building, a 50 gallon oil fired hot water heater and a washer and dryer. The boiler was installed in 1991 and is serviced every other year and was last inspected in June 2016. At the time of inspection, there were no noted issues with the boiler. However, based upon the age of the boiler, for planning purposes, a boiler replacement should be incorporated into the 20-Year Capital Improvement Plan. In addition, the clothes washer for the utility personnel clothing was not working and may also be considered by the Township for replacement.

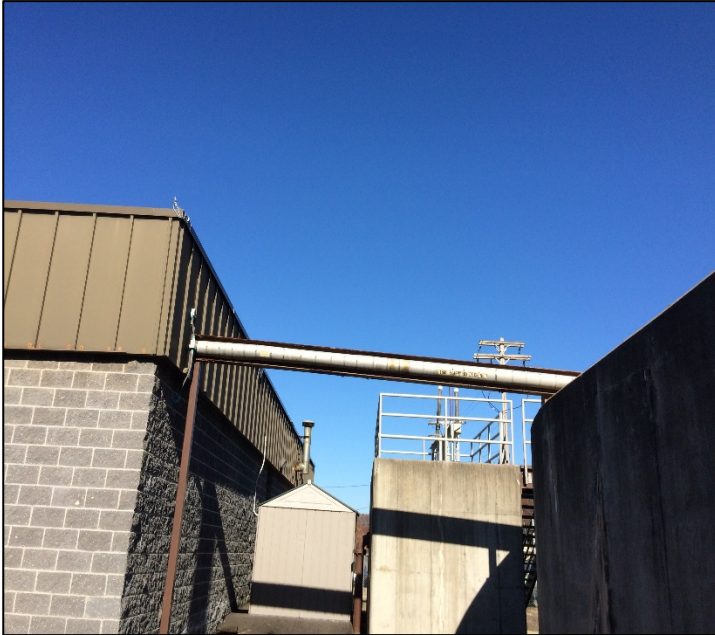
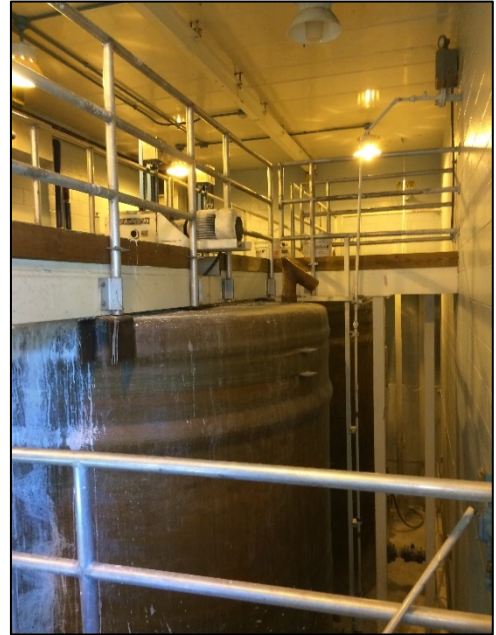
Photo #86 – Above grade lime piping to Oxidation Ditch

Photo #87 – Slurry Tanks / Room

The tanks and mixers were installed in 1991. The mixers and pumps are original and need to be replaced. The tanks are currently in good condition but have an anticipated useful life of 30 years and should be planned into the 20-Year Capital Improvement Plan. The lime transfer pumps are also original but only utilized once per week. Accordingly, the transfer pumps may only require replacement once over the planning period.

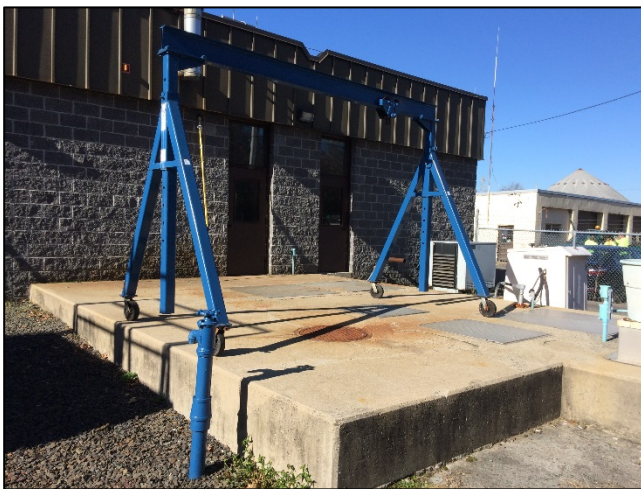
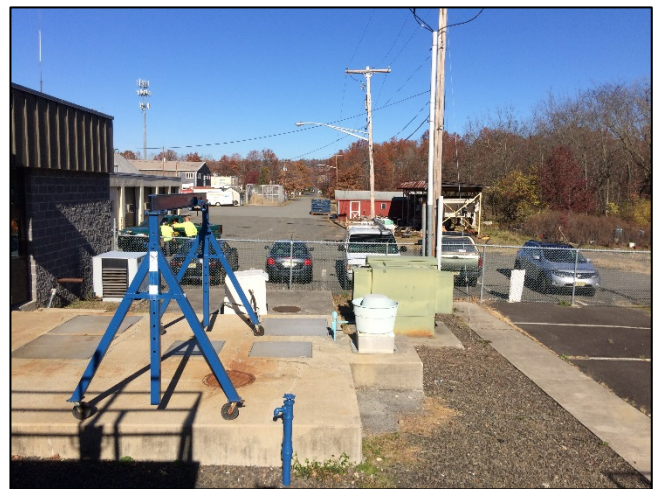
Photo #88 –Influent Pump Station

Flows enter the treatment plant into the influent pump station; located at the rear of the Main Building. The station is a submersible pump station with a wet well and valve vault. The wet well is approximately 25' deep. There are four (4) submersible pumps in the wet well; all Flygt pumps. The pumps are of varying speed and HP; consisting of:

Due to the wear on the pumps, normal maintenance should include pulling and inspecting the pumps every 2 years. At the time, bearings and seals should be replaced. In addition to the routine maintenance, one (1) pump replacement should be planned every other year; resulting in a pump being replaced every 8 years. As noted previously in this report, the replacement schedule is for budgetary purposes and can be adjusted based upon performance of the pumps at the time of inspection.

A yard hydrant is located adjacent to the pump station to wash down the wet well. There are no apparent structural issues. However, it is recommended that the wet well be cleaned every month, as possible with the continuous flow, to clear the wet well of residual rags and grease.

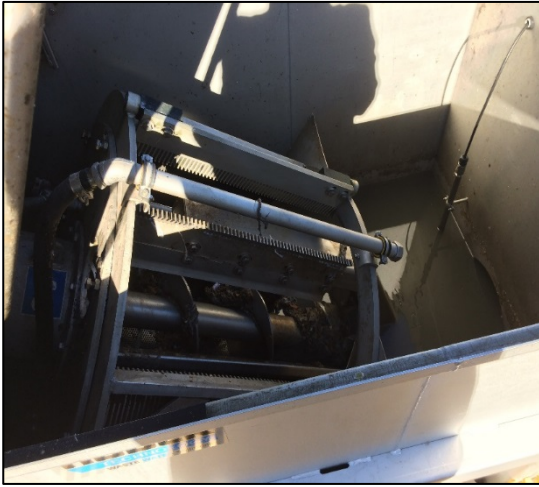
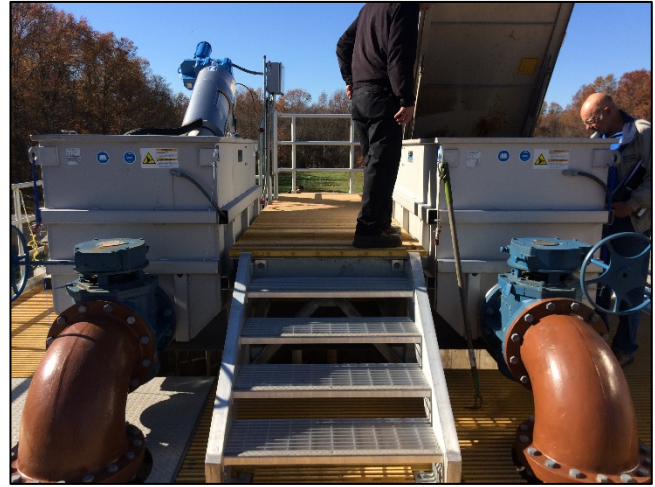
Photo #89 & #90 – Rotary Drum Screens

From the influent pump station, the sewage is pumped to the newer rotary drum screens located above sludge storage tank #1. The drums are having issues with rags and the sewage short circuits thru the screens when the largest influent pump is running. In lieu of the fine screens, a course screen may be better suited for this application Modifications / replacement of the rotary screens should be programmed to avoid fouling of the oxidation ditches and distribution boxes.

Once the rotary screens are replaced, routine maintenance is required to keep the screen clear. In addition, it the drums should be scheduled for replacement every 10 years due to life cycle costs of the motors and drum parts.

In addition, no grit removal is available at this time. The WWTP and pumps for the station would benefit from the addition of grit removal at the head of the plant.

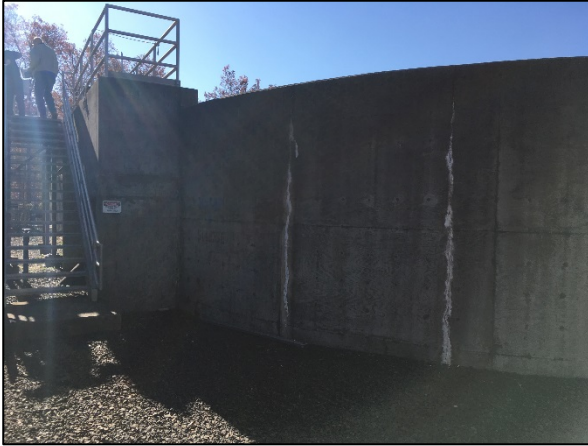
Photo # 95 & 96 – Cracks, seepage and mineral buildup on oxidation ditch structures

The structures of the two oxidation ditches consist of reinforced concrete construction with steel framed access stairs, walkways and landings with aluminum grating and handrails. At the exterior of the tanks are large vertical stress cracks that are evident at regular intervals within mineral buildup surrounding the outline of the crack. This indicates some degree of seepage and resulting corrosion of the concrete structure at these location. All cracks should be sealed from the inside of the tanks and a concrete repair mixture specifically designed for wastewater applications should be applied.

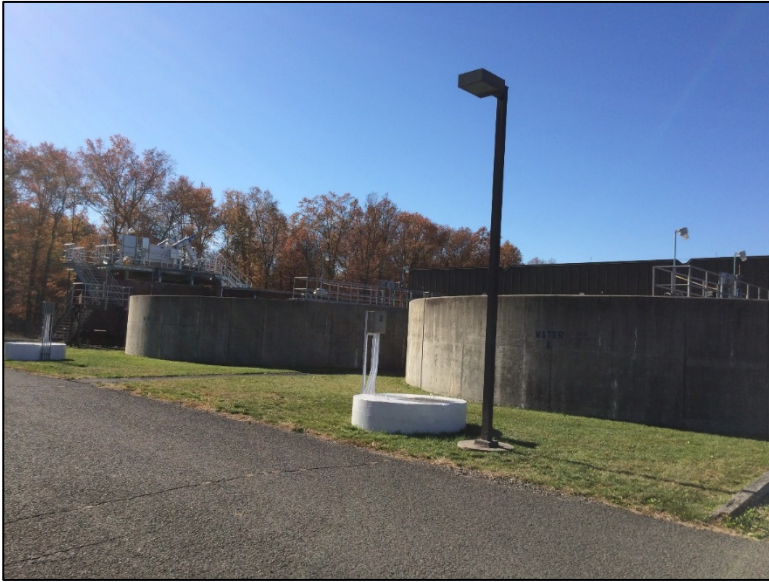
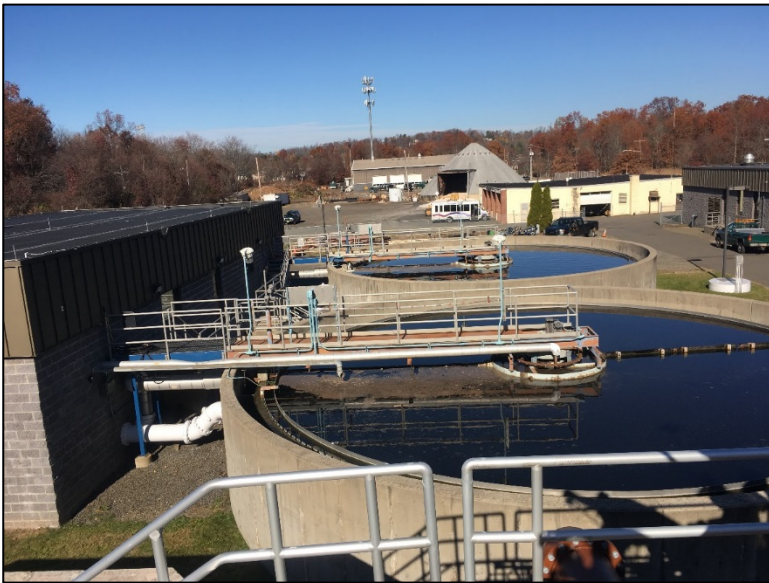
Photo #97 – Clarifier No. 1 (right) and Clarifier No. 2 (left)

Photo #97A – Clarifier No. 1 (background) and Clarifier No. 2 (foreground)

The clarifiers are 50' diameter, half bridge tanks. They are similar in construction to the oxidation ditches with poured concrete walls and a steel framed access platform with aluminum handrails and grating. It should be noted that the steel beam framing was previously epoxy coated but this coating appears to have worn off from corrosion over time. These tanks also exhibit the large vertical stress cracks found in the oxidation tanks and warrant the same proposed repairs. It should be noted that in 2016, Clarifier #1 had a blow out from one of the vertical stress cracks.

Utility personnel noted that the clarifiers are drained twice per year for maintenance. During one of the maintenance periods, the tanks should also be blasted and painted.

The half arm mixers should be replaced in both clarifiers once over the planning period. At the same time, the motors for the mixing arms should be replaced as well.

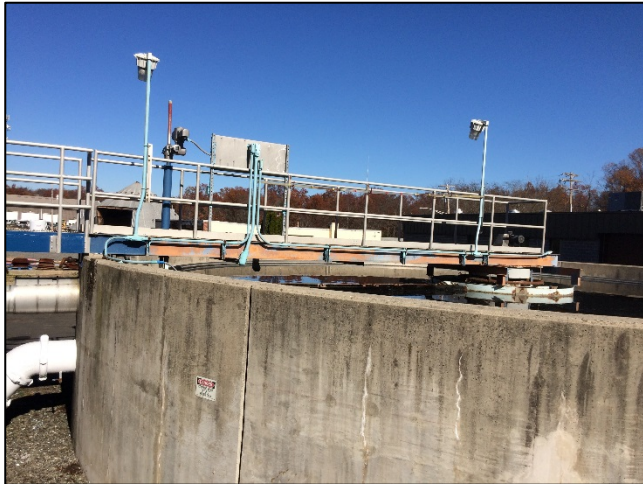
Photo #98 – Half bridge rotating arm and controls

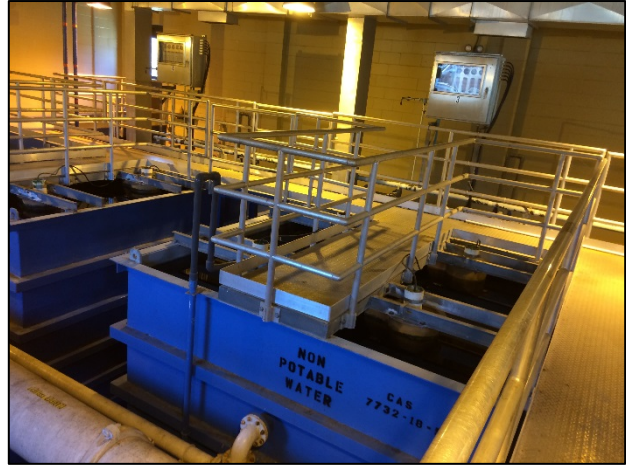
Photo #101 – RAS pumps No. 1& 2 with filters

It should be noted that the utility is currently having operational issues with RAS pumps No. 3 & No. 4. Accordingly, the pumps should be pulled and replaced as needed to rectify the situation and allow complete operation of the four pumps.
